**BROWNS POND DAM  
MA 00192**

**PHASE 1 INSPECTION REPORT  
NATIONAL DAM INSPECTION PROGRAM**

**DECEMBER 1978**

Identification No:	MA 00192
Name of Dam:	BROWNS POND DAM
Town:	PEABODY
County:	ESSEX
State:	MASSACHUSETTS
Stream:	TAPLEY BROOK
Date of Inspection:	16 NOVEMBER 1978

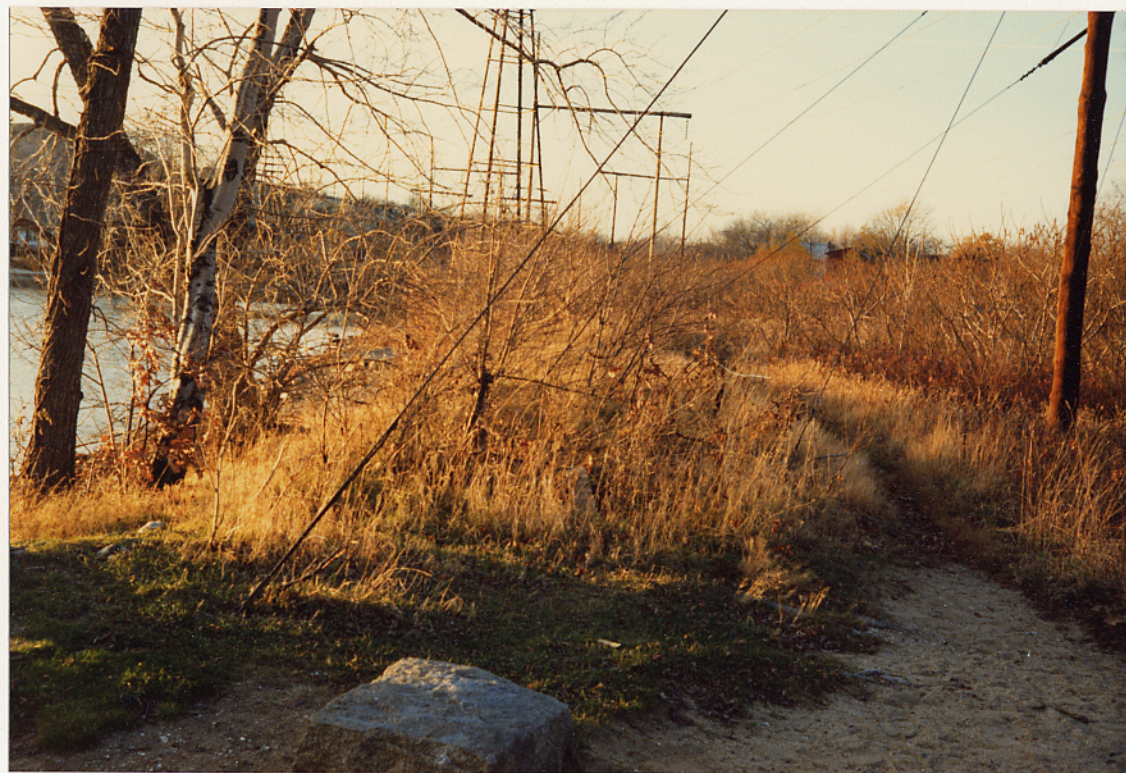
1. GENERAL OVERVIEW OF DAM.

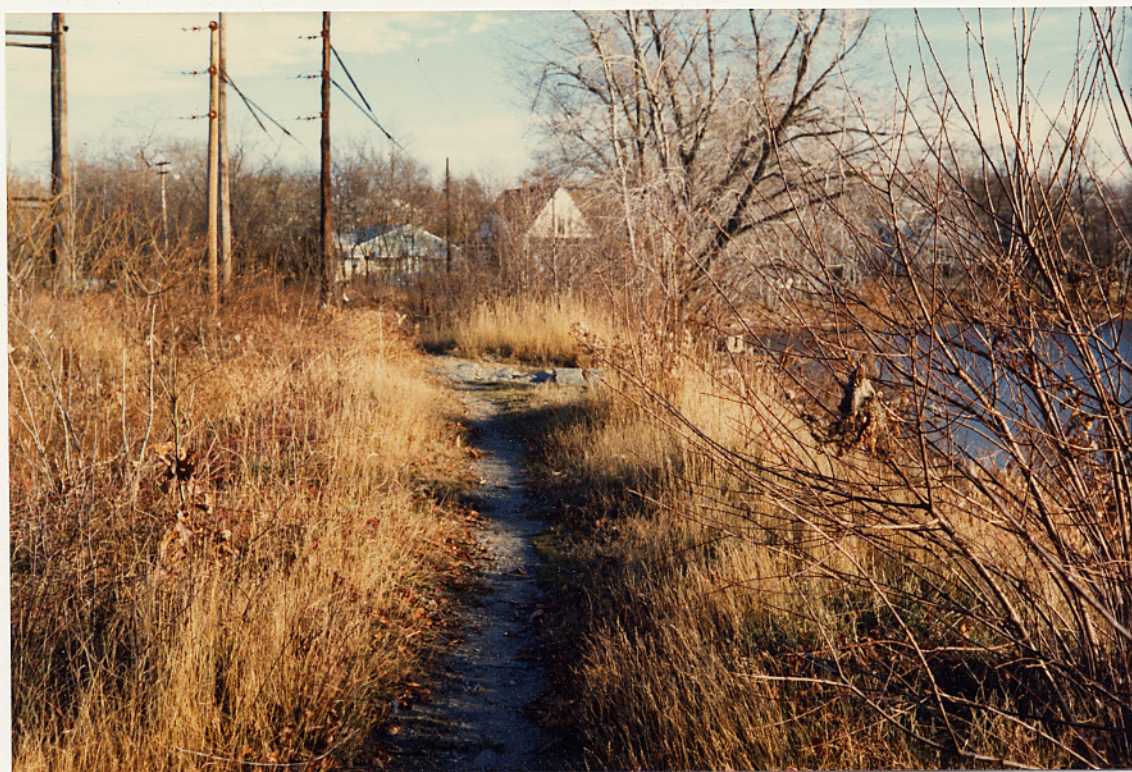
The earthfill embankment appears in generally good condition. The horizontal and the vertical alignments of the crest are generally good. There is, however, some erosion on a path, created by pedestrian traffic, for a distance of 125 feet starting at the left abutment. (See Photograph No. 2). Also at several locations, the crest edge on the upstream side has been eroded. (See Photograph No. 8). Neither longitudinal nor transverse cracks are visible on the crest, which is covered by heavy growth of trees, saplings, bushes and overgrown grass.

2. VIEW OF CREST. NOTE PEDESTRIAN PATH AND VEGETATION.

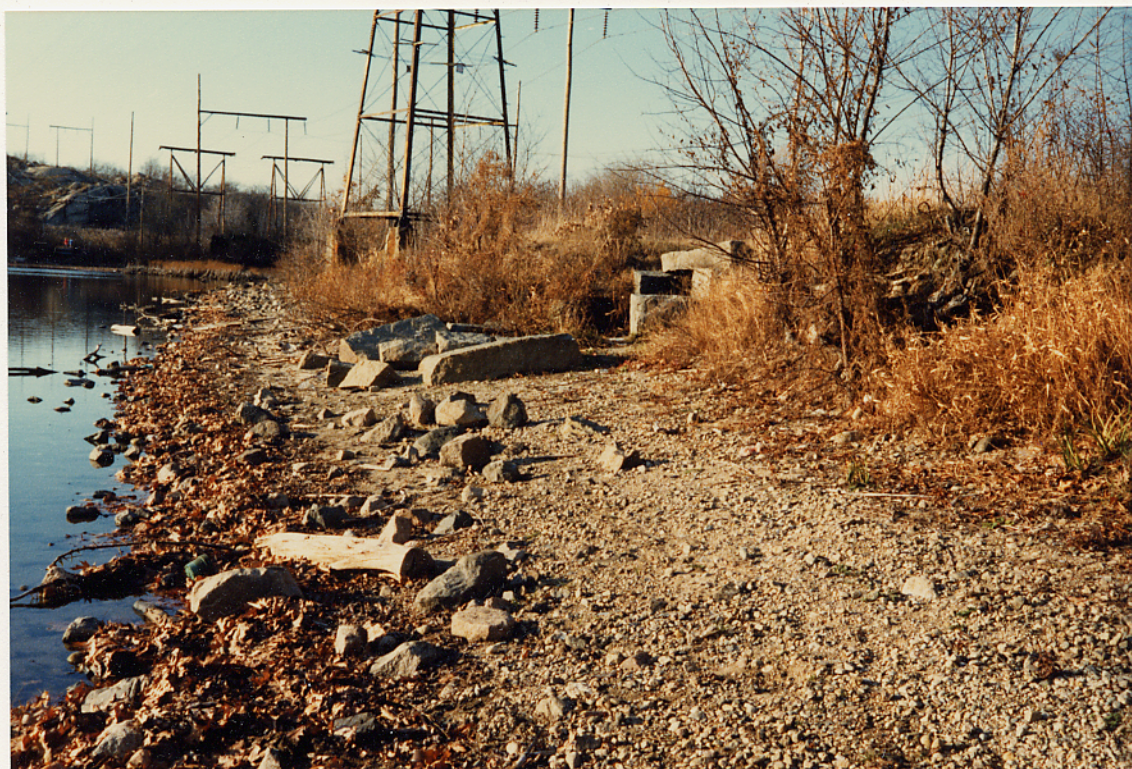
The upstream slope is in relatively fair condition. The upstream slope between the normal water level and the crest edge exhibits large expanses of erosion and sloughing. No slope protection is provided on the upstream slope. (See Photograph No. 3).

There were no signs of seepage or other unusual conditions at the abutments. At the left abutment there is a high voltage transmission tower. (See Photograph No.3.)

3. VIEW OF UPSTREAM SLOPE. NOTE VEGETATION AND HIGH VOLTAGE TRANSMISSION TOWER.

6. The gullies and sloughed areas of the upstream slope should be filled with suitable material and compacted.
7. Stone blocks at the entrance and exit of the spillway should be removed.
8. Remove debris from spillway approach channel.
9. Missing stones should be replaced along the spillway training walls and all joints should be repointed.
10. The extent of the spillway outlet pipe should be determined and the broken portion of the pipe repaired.
11. The gate valve which controls discharges through the outlet pipe should be maintained in operable condition.

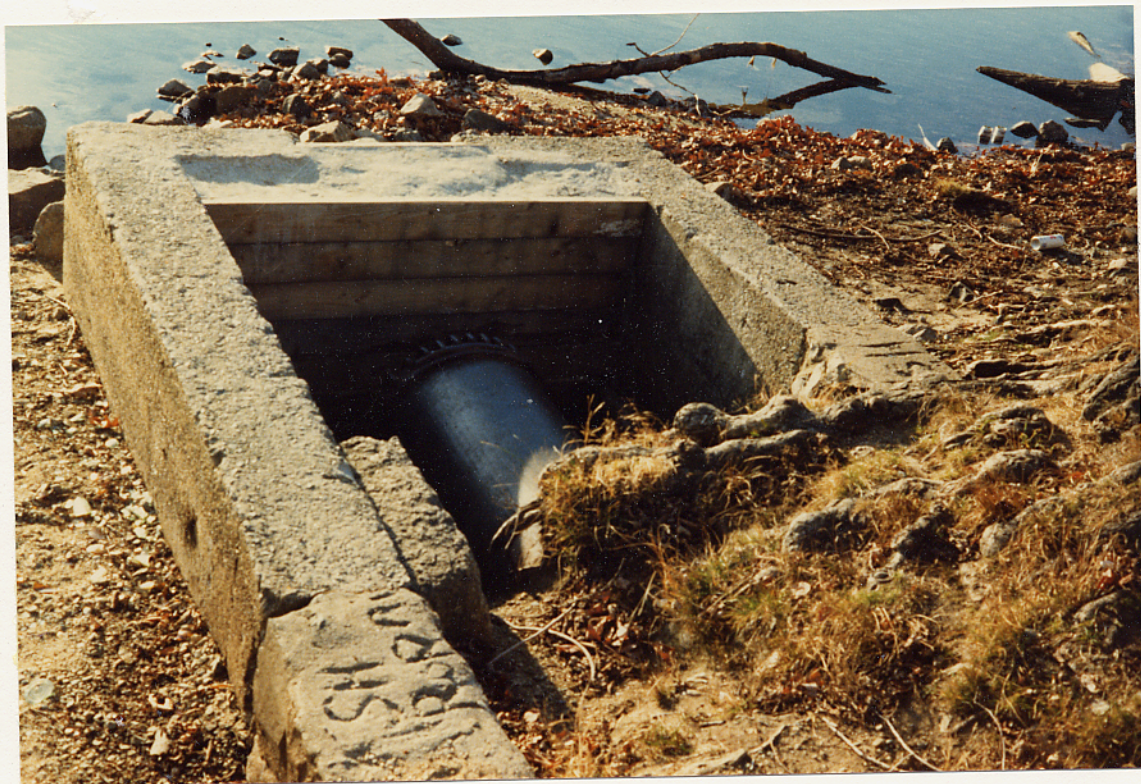
The concrete outlet structure and the 20-inch diameter cast iron outlet pipe which is protected by a steel trash rack are in good condition. The pipe shows minimal rusting and the condition of the concrete is good. (See Photograph No. 4). It is reported that the gate valve for the outlet pipe is in operating condition.

4. VIEW OF OUTLET STRUCTURE AND OUTLET PIPE. NOTE NOTCH RECENTLY CONCRETE FILLED.

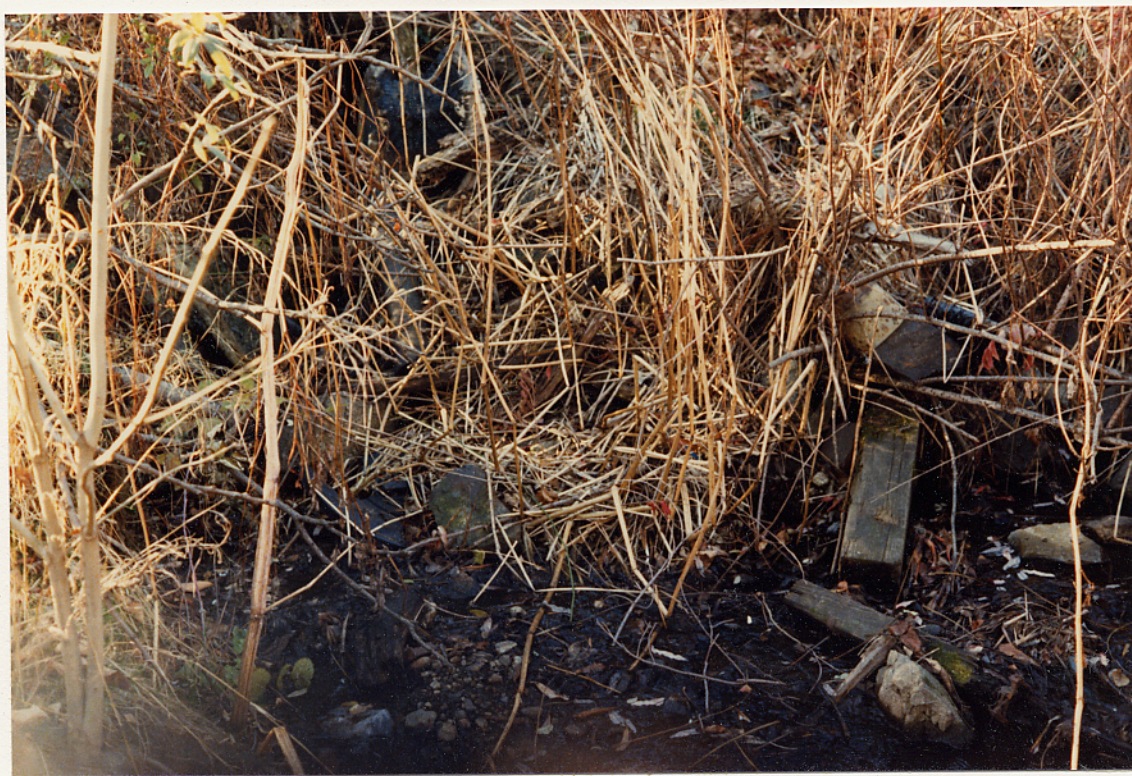
\* Photograph No. 5 is not taken in the vicinity of Browns Pond Dam but as described by its caption

5. VIEW OF OUTLET PIPE OUTFALL IN VICINITY OF SPRING POND PUMPING STATION.

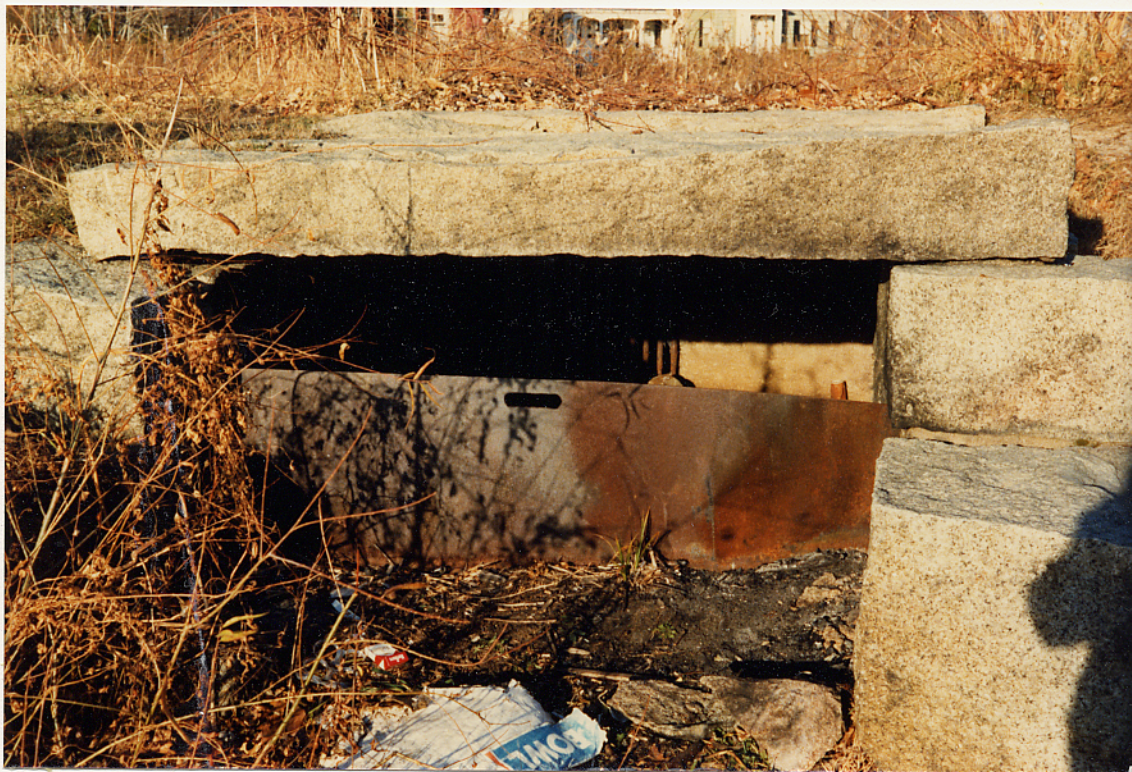
The spillway is in good condition with the upstream training walls in fair condition. The stone blocks of the upper courses of both walls

have fallen into the spillway approach channel. In addition, minor debris has accumulated in the channel. At several locations along the walls, mortar in the joints is loose and missing. At the time of inspection, there was a steel plate flashboard at the entrance to the spillway. (See Photograph No. 6).

6. VIEW OF SPILLWAY LOOKING DOWNSTREAM.  
NOTE STEEL PLATE FLASHBOARD AND IN BACKGROUND HEADWALL  
WITH ENTRANCE TO OUTLET PIPE COVERED WITH TRASH RACK.

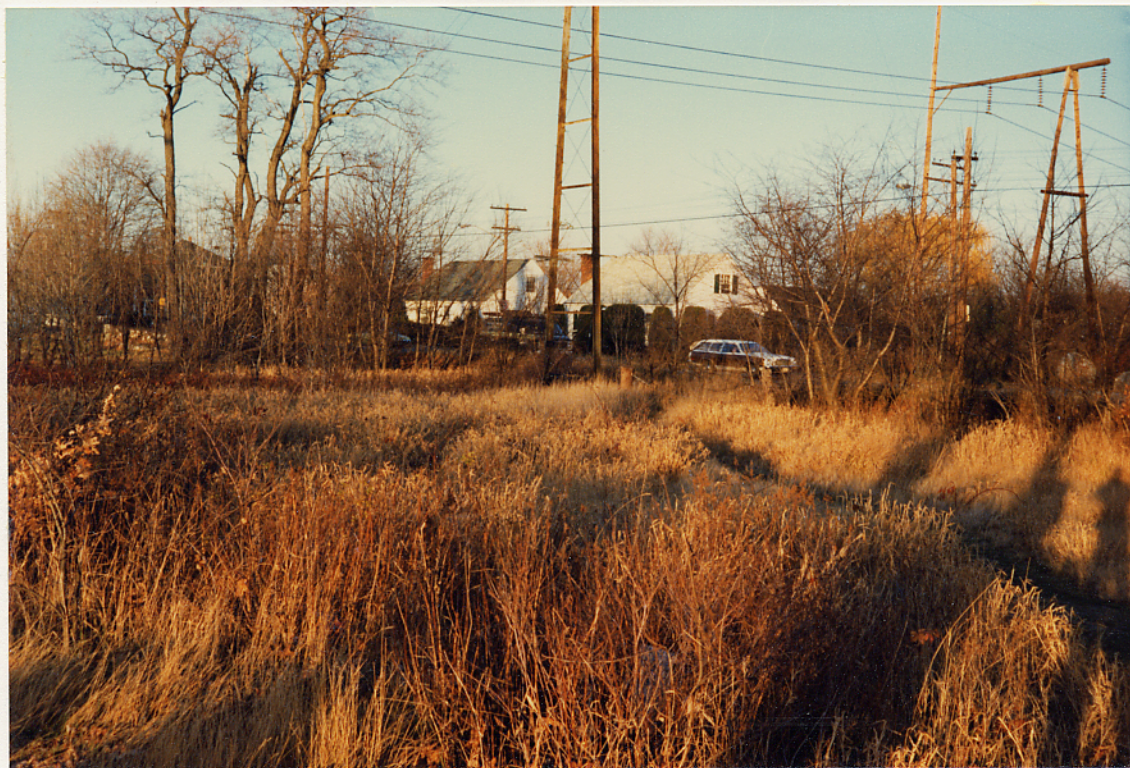
7. VIEW OF DOWNSTREAM CHANNEL. NOTE VEGETATION.

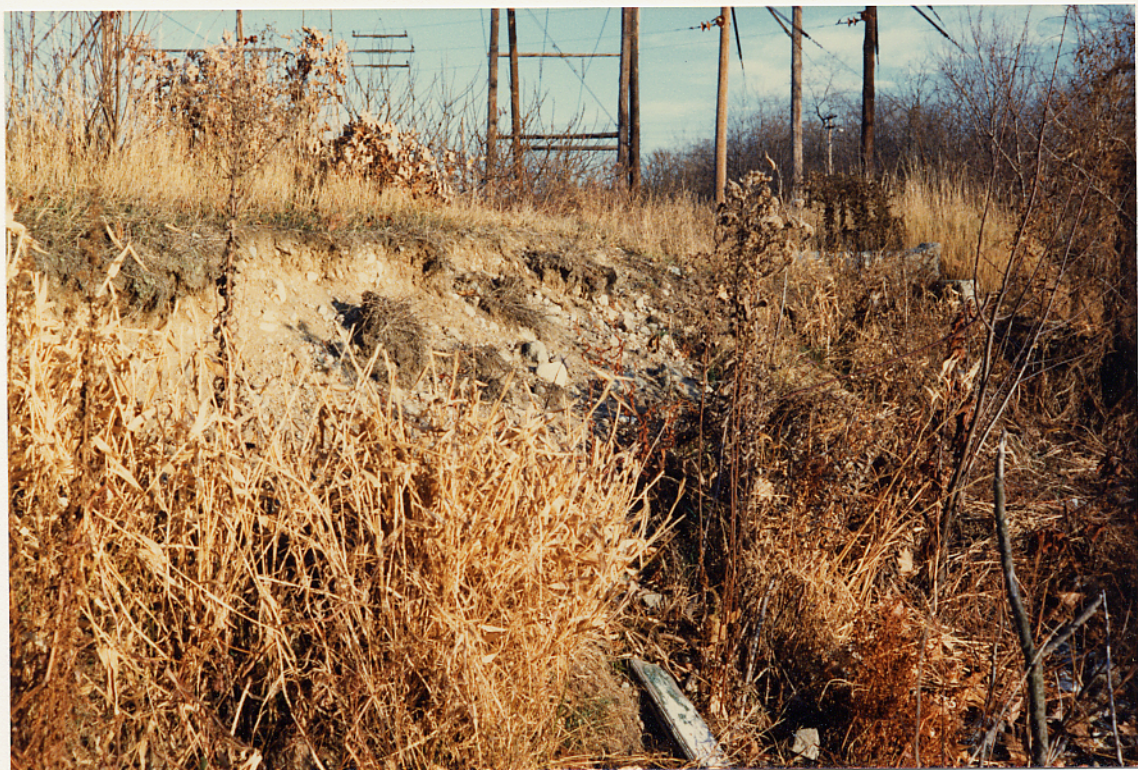
8. VIEW OF UPSTREAM SLOPE. NOTE SLOUGHING BELOW CREST AND VEGETATION.

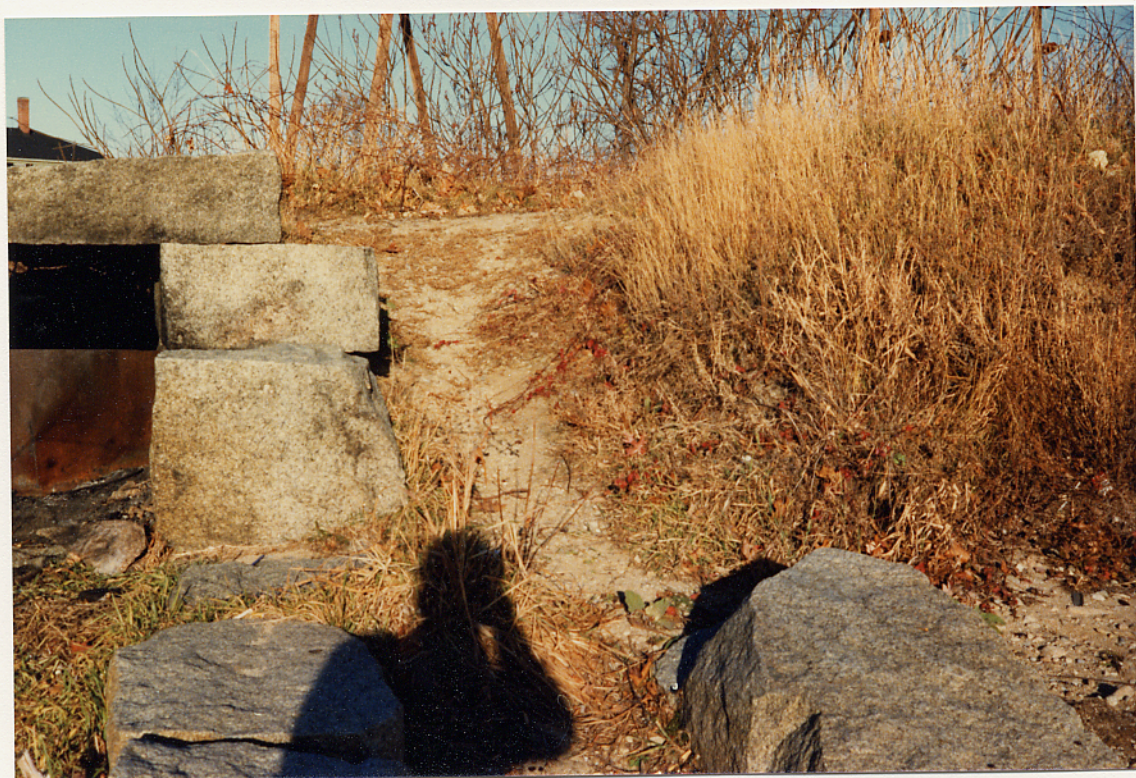
9. VIEW OF GULLY ON UPSTREAM SLOPE.
